CAFO FACILITY INSPECTION REPORT

<u>8365986001</u> WDID NUMBER	<u>Pat Carrigan</u> OWNER NAME	<u>American Beef Packers</u> FACILITY NAME
<u>CAG018001</u> NPDES NUMBER	<u>Ex. 6 Personal Privacy (PP)</u>	
<u>R8-2007-0001</u> RWQCB ORDER NO.	<u>Chino, CA 91710</u> OWNER CITY AND STATE	<u>Ontario, CA 91762</u> FACILITY CITY AND STATE
<u>03-06-2013</u> SCHEDULED INSPECTION DATE	<u>Pat Carrigan</u> OWNER CONTACT	<u>Sam Sousa</u> FACILITY CONTACT
<u>03-06-2013</u> ACTUAL INSPECTION DATE	<u>Ex. 6 Personal Privacy (PP)</u>	
<u>Unknown</u> RECEIVING WATER	<u>Ex. 6 Personal Privacy (PP)</u>	
	FACILITY LATITUDE	FACILITY LONGITUDE

REPORT PREPARED BY: Anthony D'Angelo (PG Environmental, LLC) ON 03/14/2013

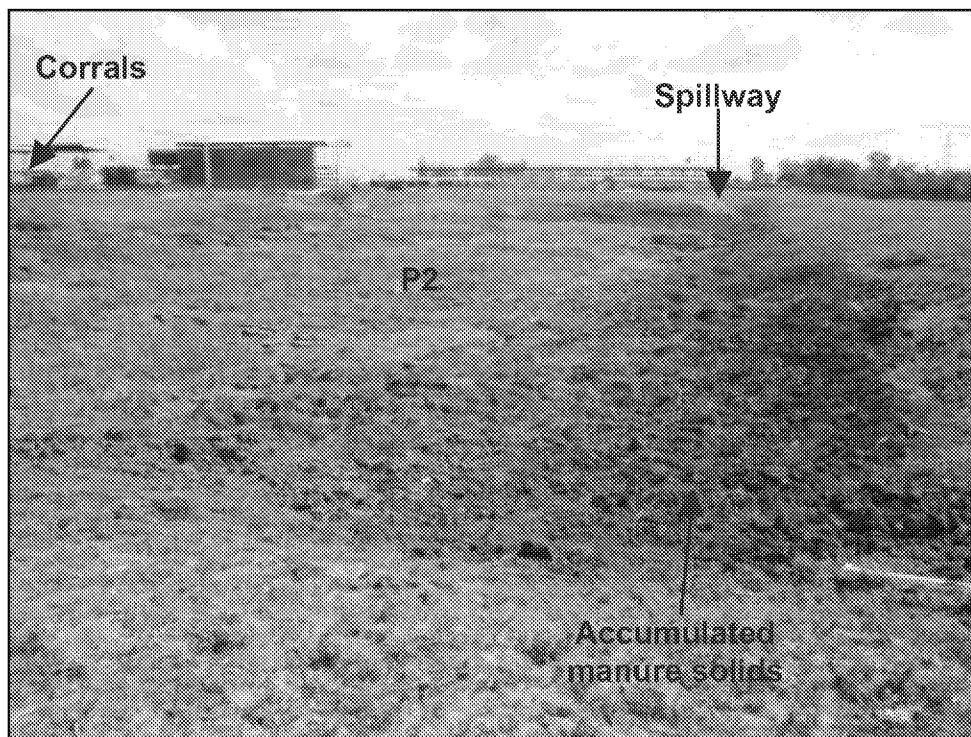
1. Depth markers were not installed in the three storage ponds, P1, P2, and P9, located in the southern and south-western portion of the Facility as required by Permit Attachment B - Monitoring and Reporting Program, Section I.B.1 (refer to Photos 2, 4, and 10). This is a recurring issue identified in a previous inspection conducted on September 24, 2008.

1. The inspectors observed, during the inspection, that depth markers were not installed in the three existing storage ponds, P1, P2, and P9, located in the southern and south-western portion of the Facility as required by Permit Attachment B - Monitoring and Reporting Program, Section I.B.1 (refer to Photos 2, 4, and 10). In addition, accumulated manure solids was observed inside P1 and P2; however, the inspectors could not determine the depth of the solids within each containment structure due to the lack of depth markers. This is a recurring issue identified in a previous inspection conducted on September 24, 2008.

3. The EWMP was not fully implemented onsite and the containment structures were not adequately maintained at the Facility as required by the Permit. Section V - 'Operation and Maintenance', Item E - 'Solids Removal' states "as soon as practicable following the ending of the wet season, solids shall be removed from the containment basins to restore the minimum required available capacity of the basins prior to the next wet season." Accumulated manure solids and trash/debris was observed in P1 and P2 (refer to Photos 2 through 7). Mr. Sousa stated that per the Facility lease agreement with San Bernardino County (Owner/Discharger), he is not required to clean the ponds of any solids that accumulate in the bottom and that the ponds had not been cleaned of manure solids since American Beef Packers began operating at the Facility approximately three (3) years prior to the inspection. As a result, the Discharger had not adequately maintained the containment structures and was not fully implementing the approved EWMP. Provision VII.C.3.a of the Permit states that "the discharger shall design, construct, and maintain containment structures to retain all wastewater within the facility, including all process wastewater and all precipitation on, and drainage through, manure areas resulting from rainfall up to and including a 25-year, 24-hour rainfall event." Provision VII.C.3.b of the Permit states that "the discharger shall develop and fully implement an Engineered Waste Management Plan (EWMP) acceptable to the Executive

3. The inspectors observed, during the inspection, accumulated manure solids and trash/debris in containment structures P1 and P2 in the southern portion of the Facility (refer to Photos 2 through 7). Mr. Sousa stated that per the Facility lease agreement with San Bernardino County (Owner/Discharger), he is not required to clean the ponds of any solids that accumulate in the bottom and that the ponds had not been cleaned of manure solids since American Beef Packers began operating at the Facility approximately three (3) years prior to the inspection. P1 and P2 did not contain depth markers; therefore, the inspectors were unable to determine the depth of accumulated manure solids in the ponds; however, an out of service floating pump was observed partially buried by the manure solids (refer to Photos 5 and 6). Section V - 'Operation and Maintenance', Item E - 'Solids Removal' states "as soon as practicable following the ending of the wet season, solids shall be removed from the containment basins to restore the minimum required available capacity of the basins prior to the next wet season." The Discharger must design and maintain all containment structures per the EWMP as required by Provision VII.C.3.a of the Permit.

Photograph 2. View facing east of P2 in the southeast portion of the Facility. The pond did not contain a depth marker. Note the accumulated manure solids in the pond.

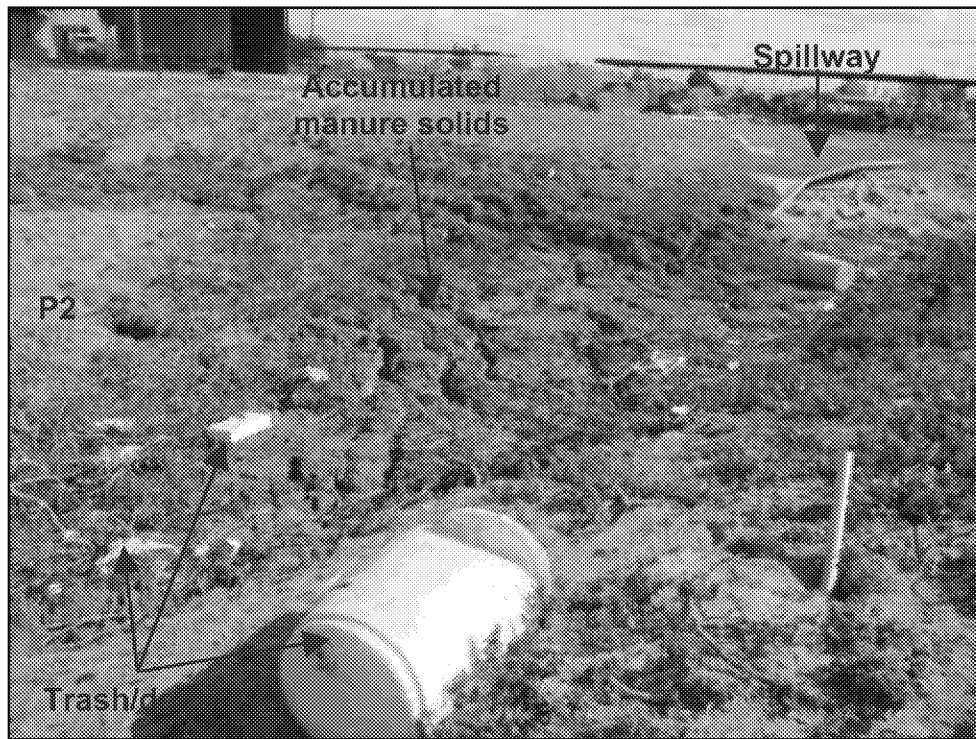
7. Accumulated manure solids and trash/debris were observed in P1 and P2 in the southern portion of the Facility (refer to Photos 2 through 7). The Discharger must design and maintain all containment structures per the EWMP as required by Provision VII.C.3.a of the Permit.

Photograph 3. View facing northeast of P2. Note the accumulated manure solids and trash/debris in the pond.

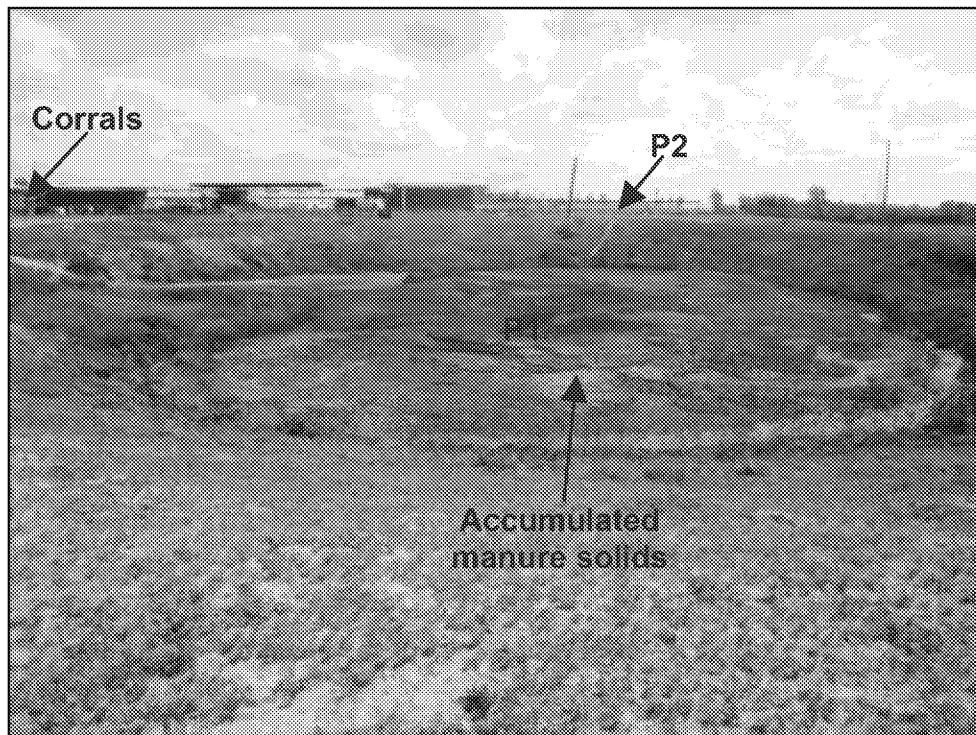
Photograph 4. View facing east of P1. Note the accumulated manure solids and lack of depth marker in the pond.

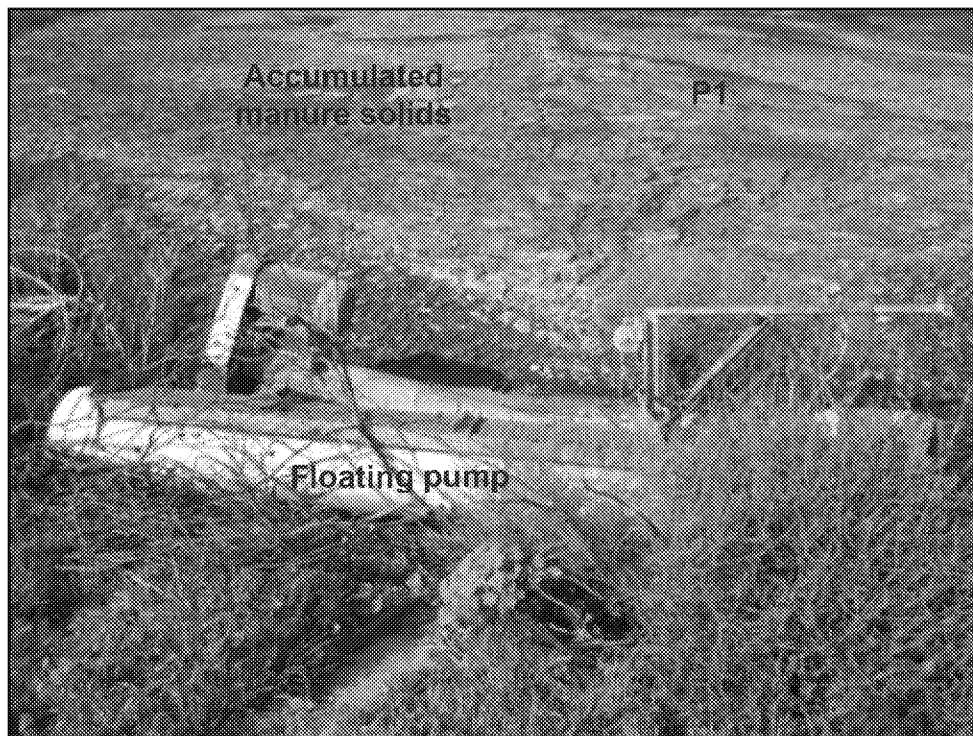
Photograph 6. Additional view of P1. Note the out of service floating pump partially buried in the accumulated manure solids.

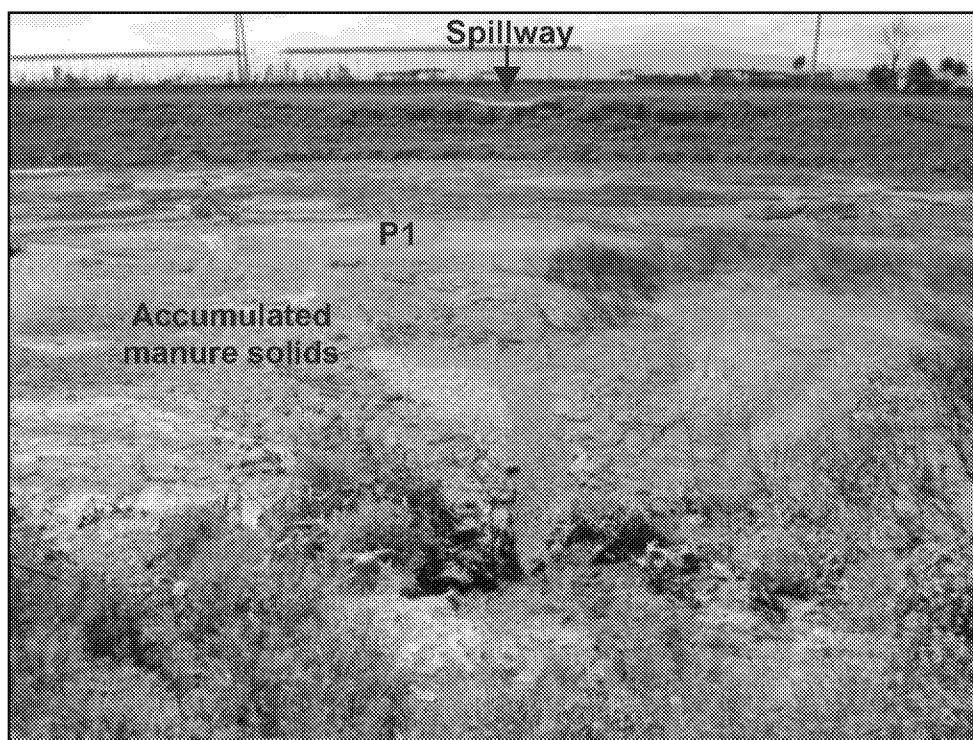
Photograph 7. View facing south of P1. Note the accumulated manure solids in the pond.

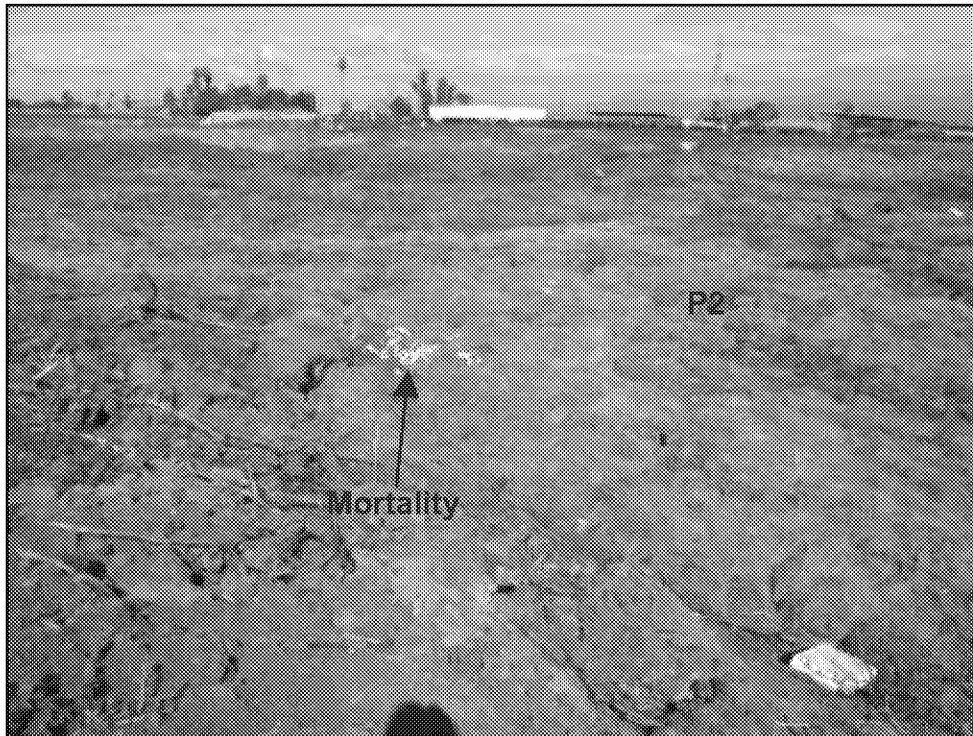
2. Evidence of previous mortality disposal (skeletal remains) was observed on the southern embankment of P2 located in the southern portion of the Facility (refer to Photos 8 and 9). Discharge Prohibition IV.F states that "the disposal of any mortality in any process wastewater system is prohibited."

2. The inspectors observed, during the inspection, evidence of previous mortality disposal (skeletal remains) on the southern embankment of P2 located in the southern portion of the Facility (refer to Photos 8 and 9). Mr. Sousa stated that all mortalities at the Facility are hauled away immediately by Stiles Animal Removal, Inc.; however, this had not been adequately implemented at the Facility. In addition, Mr. Sousa explained that he had not cleaned the ponds since he took operational control over the Facility approximately three (3) years prior to the inspection. Discharge Prohibition IV.F states that "the disposal of any mortality in any process wastewater system is prohibited."

Photograph 8. View facing northwest of P2. Note the evidence of a previous mortality disposal (skeletal remains) on the south side of P2.

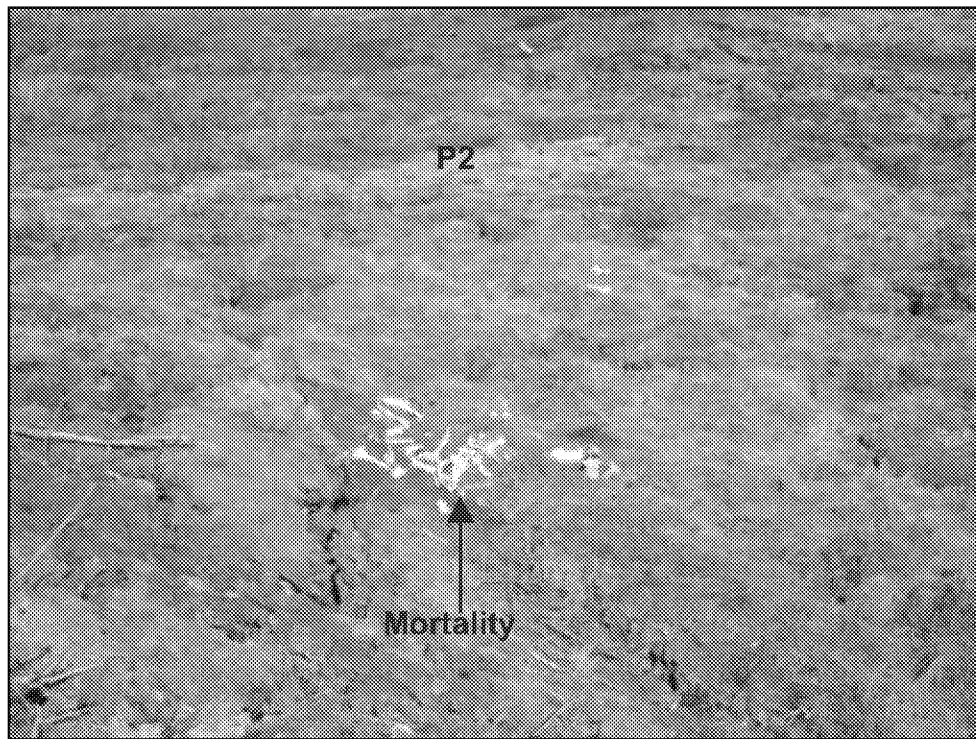
Photograph 9. Additional view of evidence of a previous mortality disposal in P2 shown in Photograph 8.

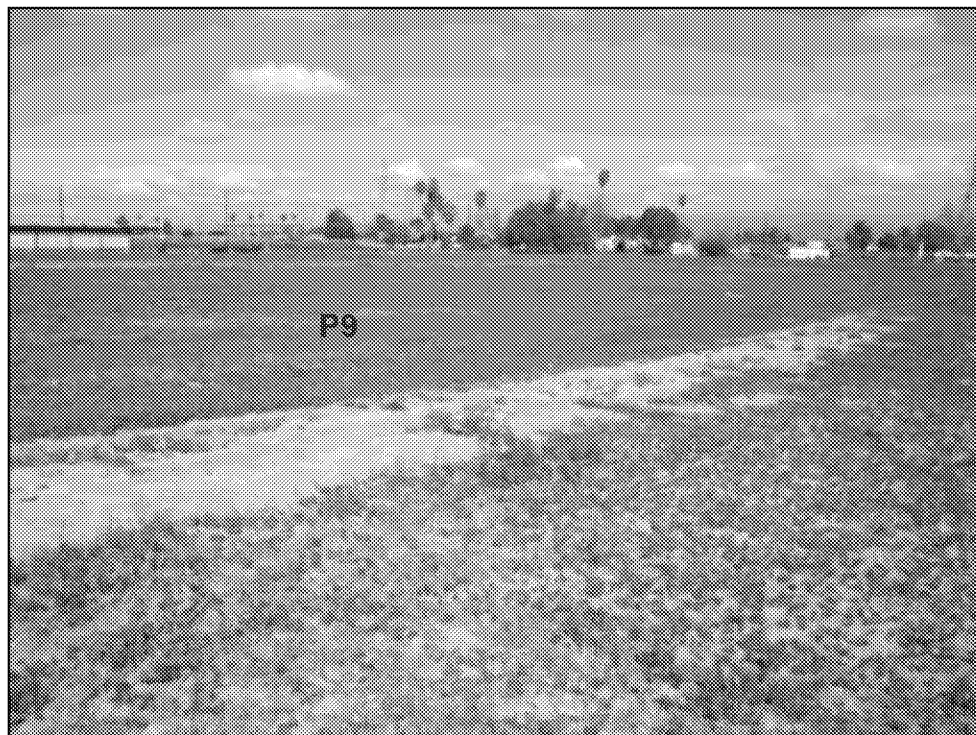
Photograph 10. View facing northwest of P9. Note the pond did not contain a depth marker.

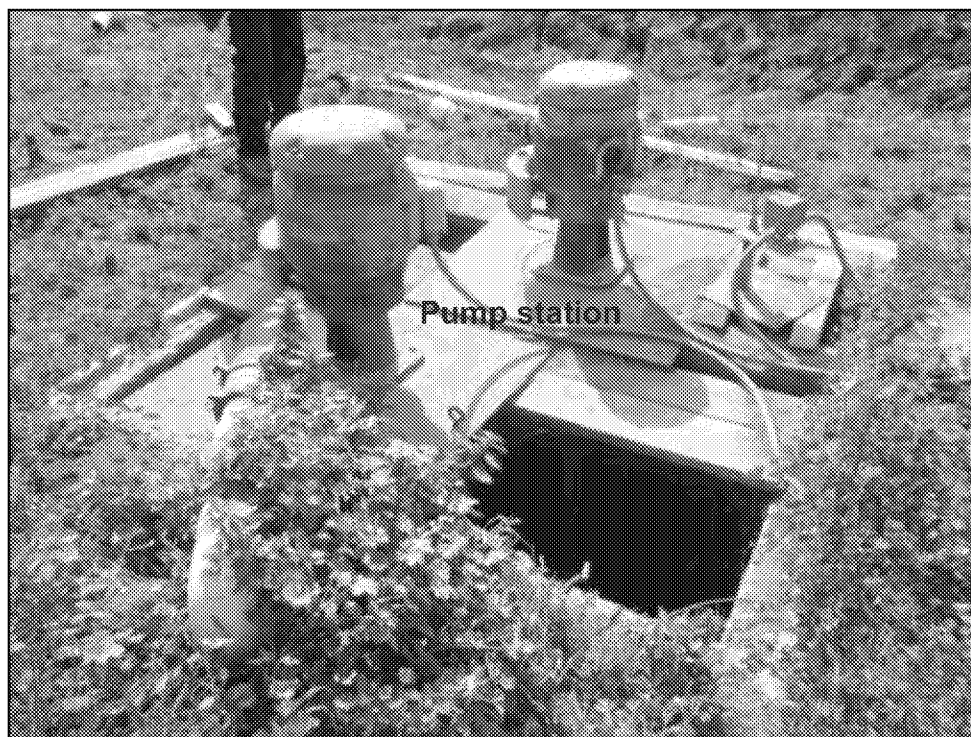
Photograph 14. Close-up view of the pump station adjacent to P1 and P2. The Facility representative stated that this pump station was not operational.

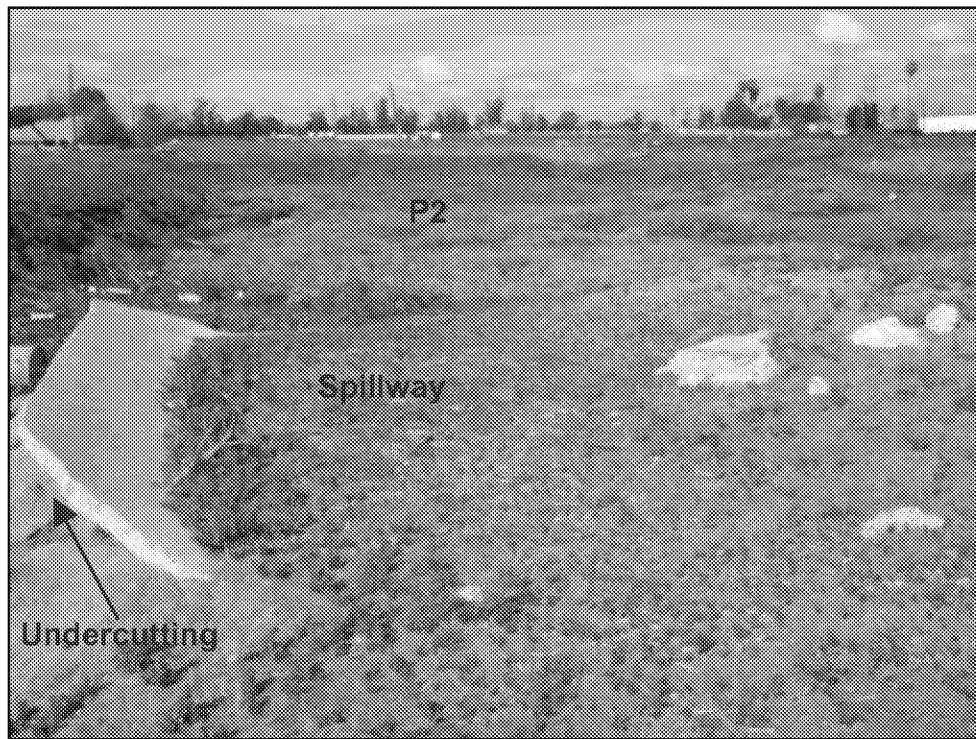
8. The concrete spillway on the east side of P2 was observed deteriorated and undercut (refer to Photos 15 and 16). The Discharger must design and maintain all containment structures per the EWMP as required by Provision VII.C.3.a of the Permit.

4. The inspectors observed, during the inspection, that the concrete spillway on the eastern side of P2 had become deteriorated and undercut, compromising the spillway's flow pathway (refer to Photos 15 and 16). Mr. Sousa stated that per the Facility lease agreement with San Bernardino County, he is not required to maintain the existing ponds in the southern portion of the Facility. As a result, the Discharger was not adequately maintaining all containment structures at the Facility. The Discharger must design and maintain all containment structures to retain all process wastewater and precipitation from a 25-year, 24-hour rainfall event at the Facility, as required by Provision VII.C.3.a of the Permit.

Photograph 15. View facing west of the concrete spillway on the east side of P2. Note the spillway was deteriorated and previous evidence of undercutting was observed.

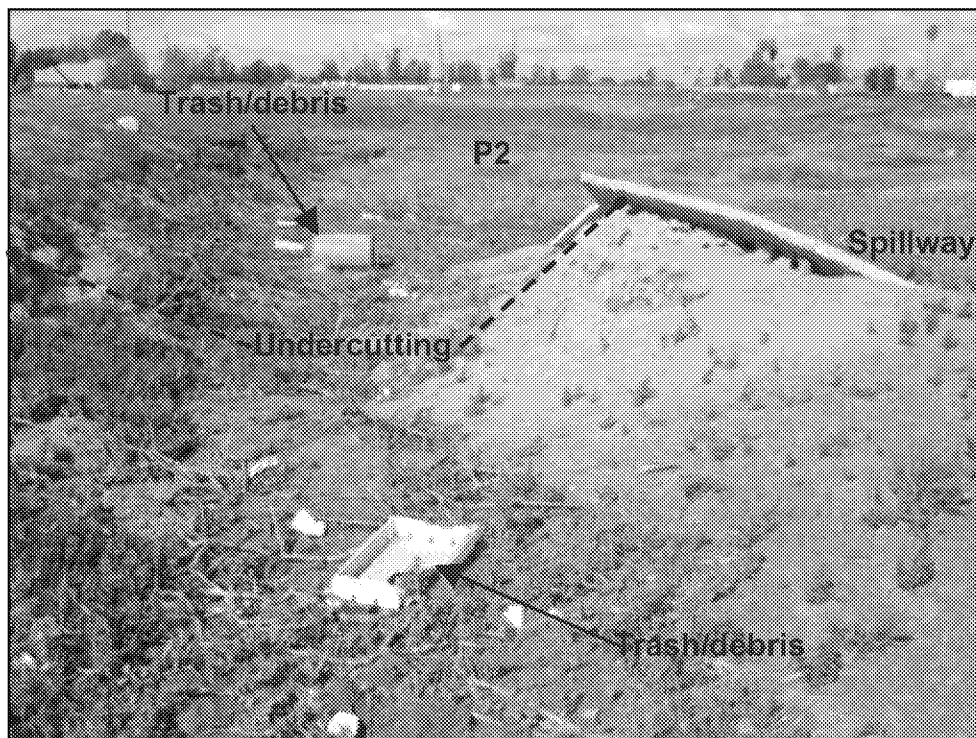
Photograph 16. View facing west of the concrete spillway on the east side of P2. Note the spillway was deteriorated and previous evidence of undercutting was observed. Note the accumulated trash/debris within the pond.

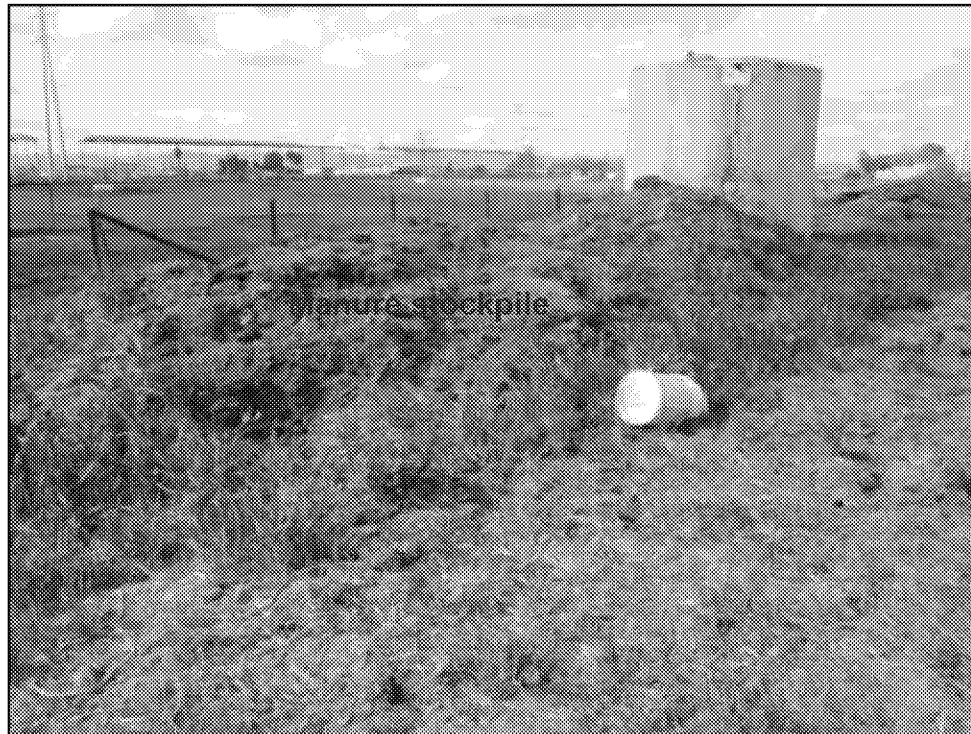
6. Manure stockpiles located in the southern portion of the Facility had not been removed from the Facility within 180 days as required by Provision VII.C.5.e of the Permit (refer to Photos 18 and 19).

1. The inspectors observed, during the inspection, a manure stockpile with vegetation growth located in the southern portion of the Facility, northeast of P2 (refer to Photos 18 and 19). Mr. Sousa stated that the manure stockpile was leftover from the previous tenant and most likely had been stored at that location for multiple years. As a result, the manure stockpile had not been removed from the Facility within 180 days as required by Provision VII.C.5.e of the Permit.

Photograph 18. View facing southwest of an old manure stockpile located in the south-eastern portion of the Facility.

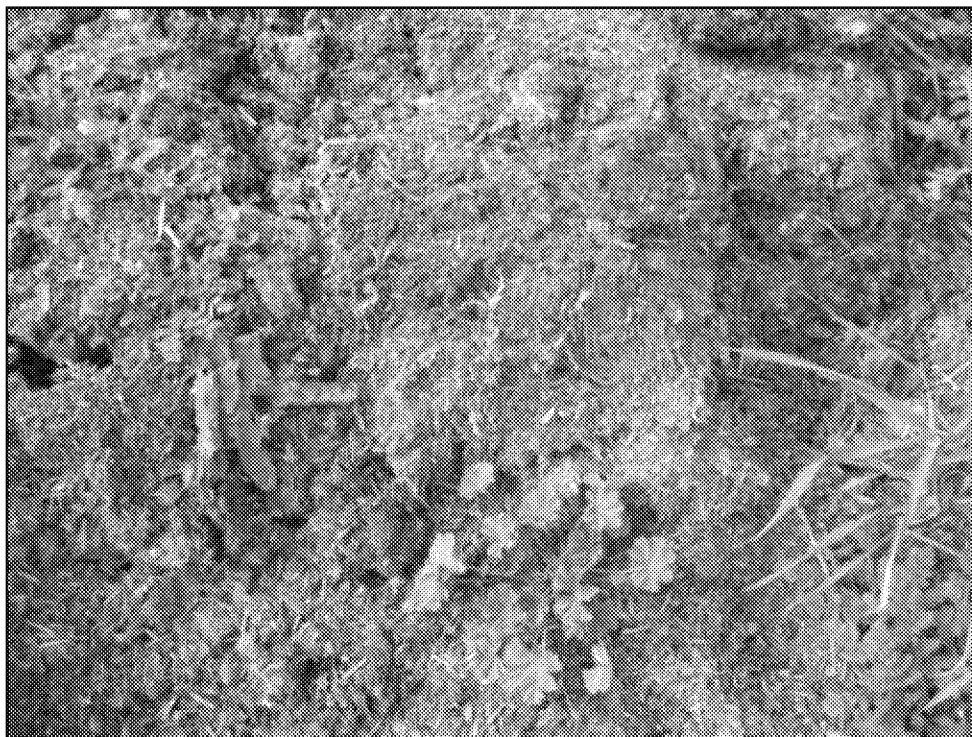
Photograph 19. Close-up view of the manure contents in the manure stockpile shown in Photograph 18.

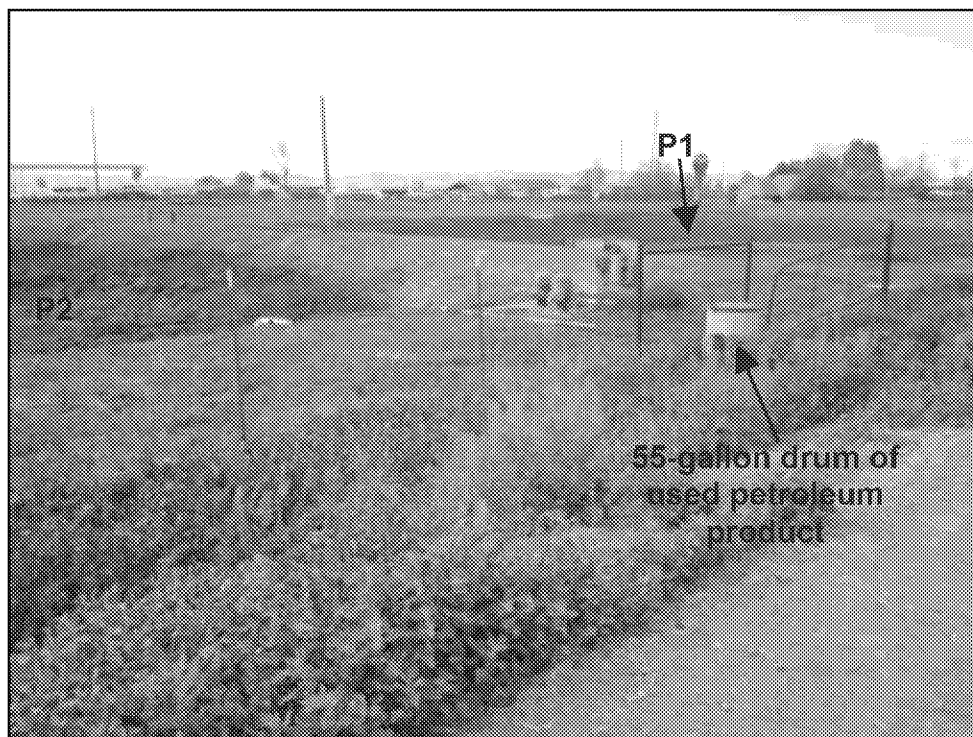
2. The inspectors observed, during the inspection, that secondary containment was not provided for a 55-gallon drum of used petroleum product in the southern portion of the Facility, in between P1 and P2 to the north (refer to Photos 20). Petroleum staining was observed on the sides of the drum and on the ground surface underneath. In addition, a bung cap was not in place for the drum (refer to Photos 21 and 22). Provisions VII.C.5.h of the Permit states that "chemicals and other contaminants handled onsite shall not be disposed of in any manure, litter, process wastewater, or storm water storage or treatment systems." The inspectors did not observe a disposal of chemical into any of the areas outlined above; however, the lack of secondary containment and visible staining on the ground surface creates a potential for petroleum to be spilled and/or released into the adjacent existing ponds.

Photograph 20. View facing southwest of a 55-gallon drum of used petroleum product located north of P1 and P2. Note the drum did not have adequate secondary containment or a bung cap.

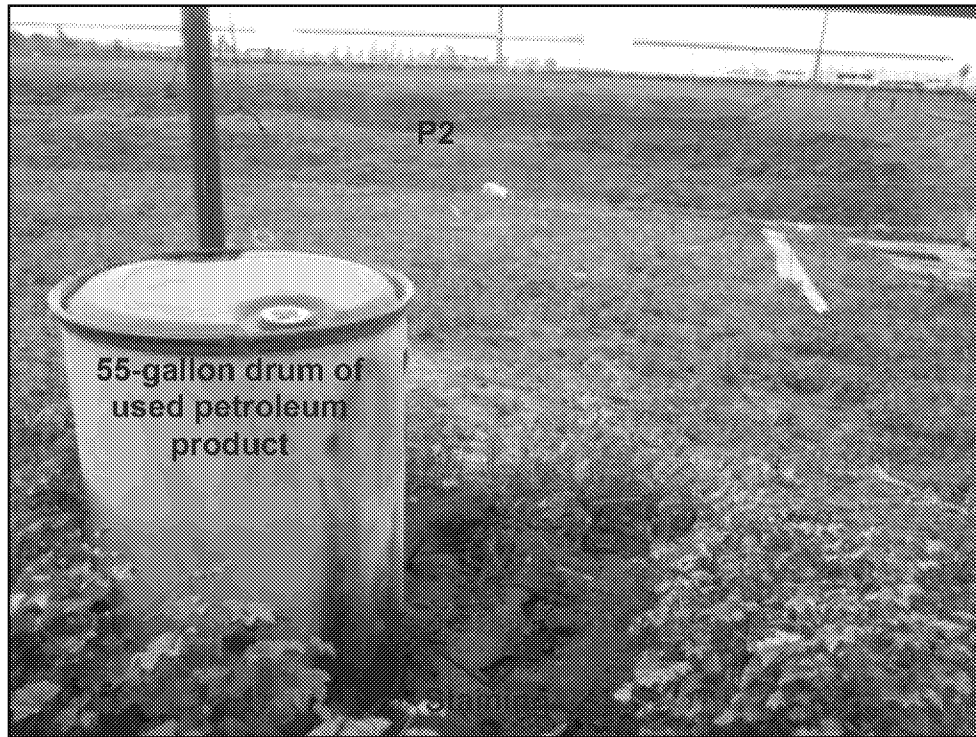
Photograph 21. View facing south of a 55-gallon drum of used petroleum product located north of P1 and P2, shown in Photograph 20. Note the staining on the sides of the drum and on the ground underneath.

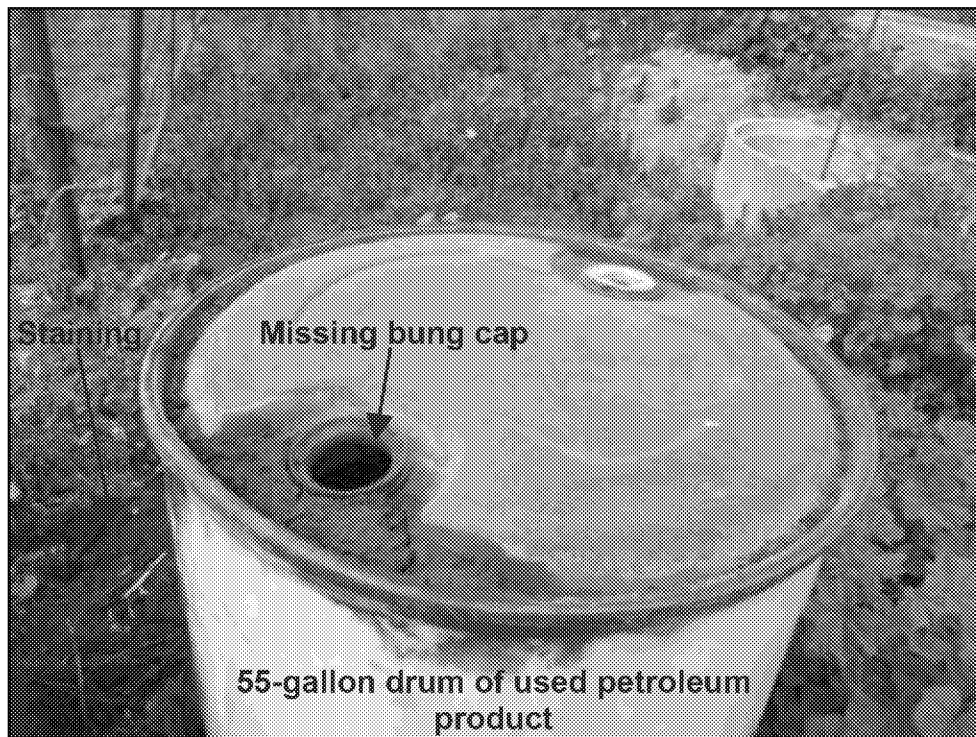
Photograph 22. Close-up view of the missing bung cap in the 55-gallon drum of used petroleum product shown in Photographs 20 and 21.
